An acoustic emission study of structural steel columns used for offshore platforms

Robert W. Kowalik
Lehigh University

A Thesis

The Department of Materials Science and Engineering

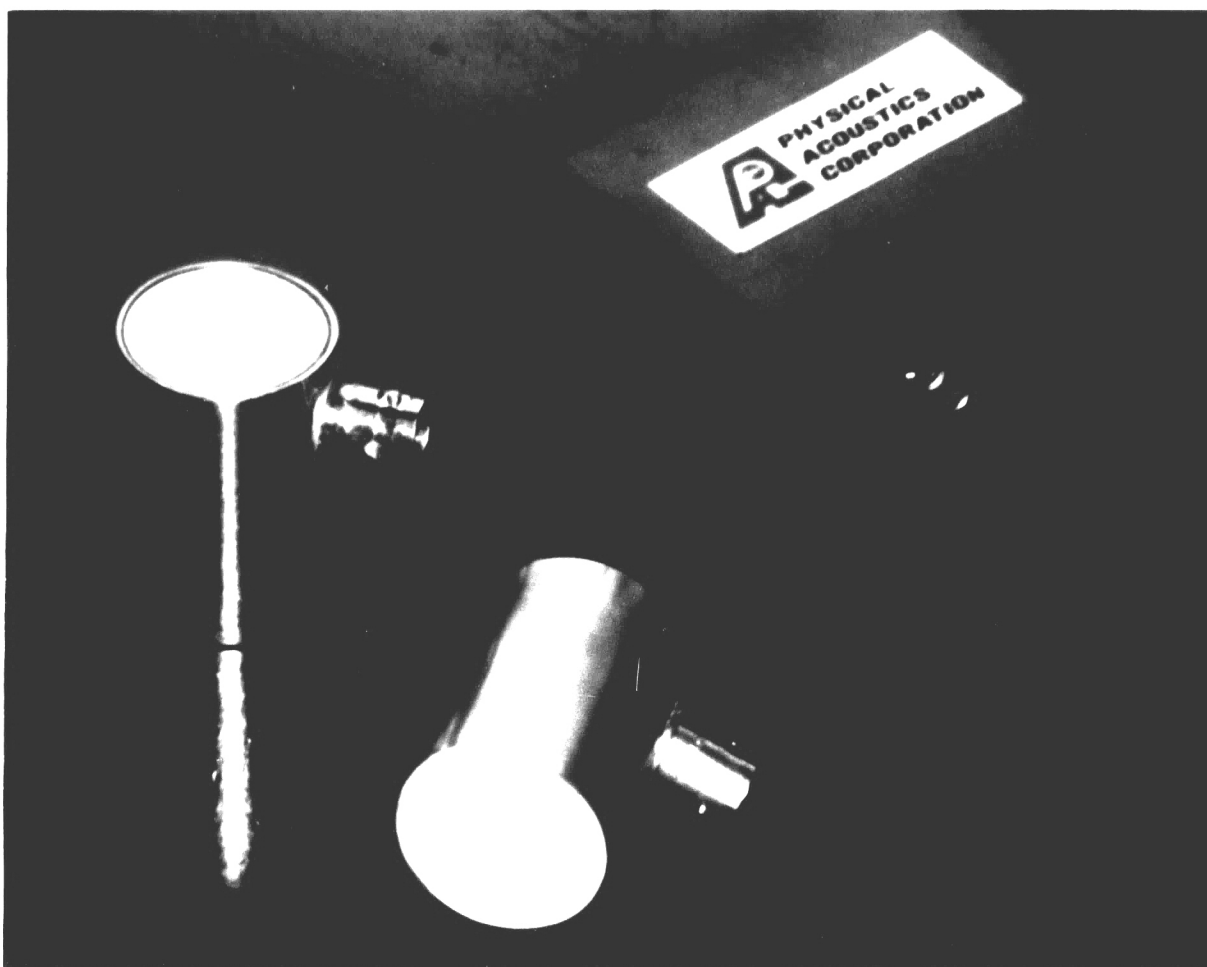
Figure 3. Two R6I Acoustic Sensors With Built-in 40dB Preamplifiers. A magnetic hold-down can be viewed in the upper right.

The acoustic equipment utilized in this thesis was supplied by Physical Acoustic Corporation. Two types of transducers (sensors) were used in this study - R6I and R6. The R6I sensor has a 40 dB preamplifier built into the sensor housing while the R6 requires a separate preamplifier (Figures 3 & 4). The approximate resonant frequency of both types of transducers is 90 KHz while their typical operating frequency regime is 50 - 200 KHz. A representative frequency response curve for these transducers can be viewed in Figure 5. It can

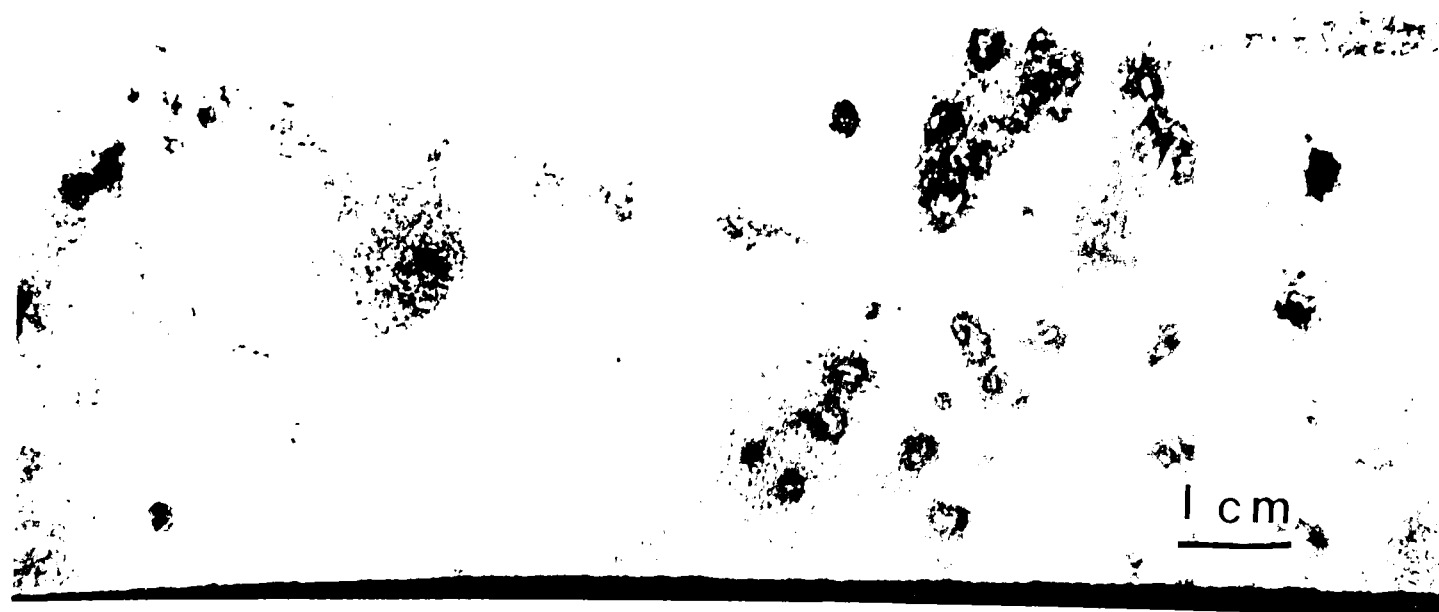
Figure 33. Surface of As Received ASTM A572 Steel Plate With Mill Scale. (Specimen F1).

Specimens with the as received coherent mill scale on them were tested (Figure 33). They all exhibited a burst of hits at the yield point (Figure 34). The amplitude of these hits are also comparatively high when compared to the polished specimens. The average amplitude of a polished specimen was 45 dB while a specimen with the mill scale averaged 65 dB. This leads to the conclusion that the generated hits from the structural columns were indeed from the mill scale spalling.

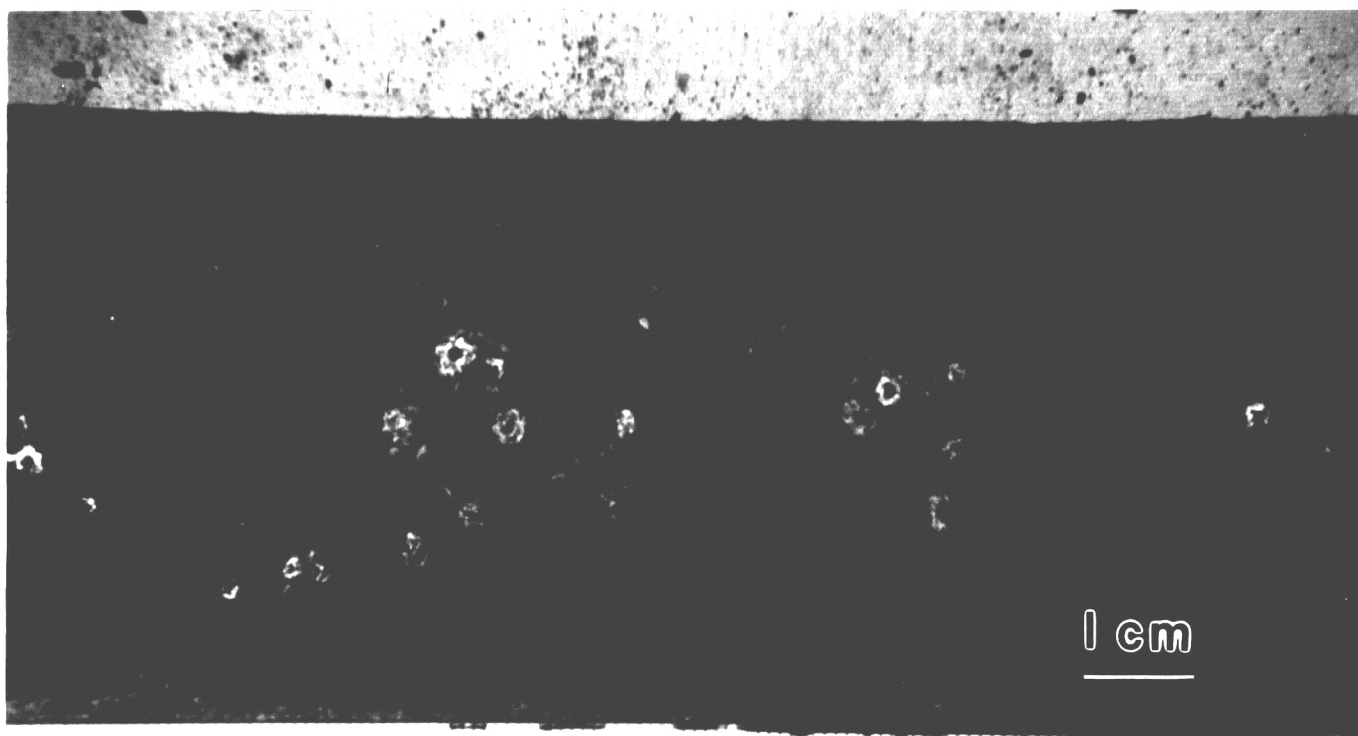
Figure 39. Surface Condition of ASTM A572 Steel Plate With Mill Scale and a 2400hr. Salt Water Exposure. (Specimen FE3).

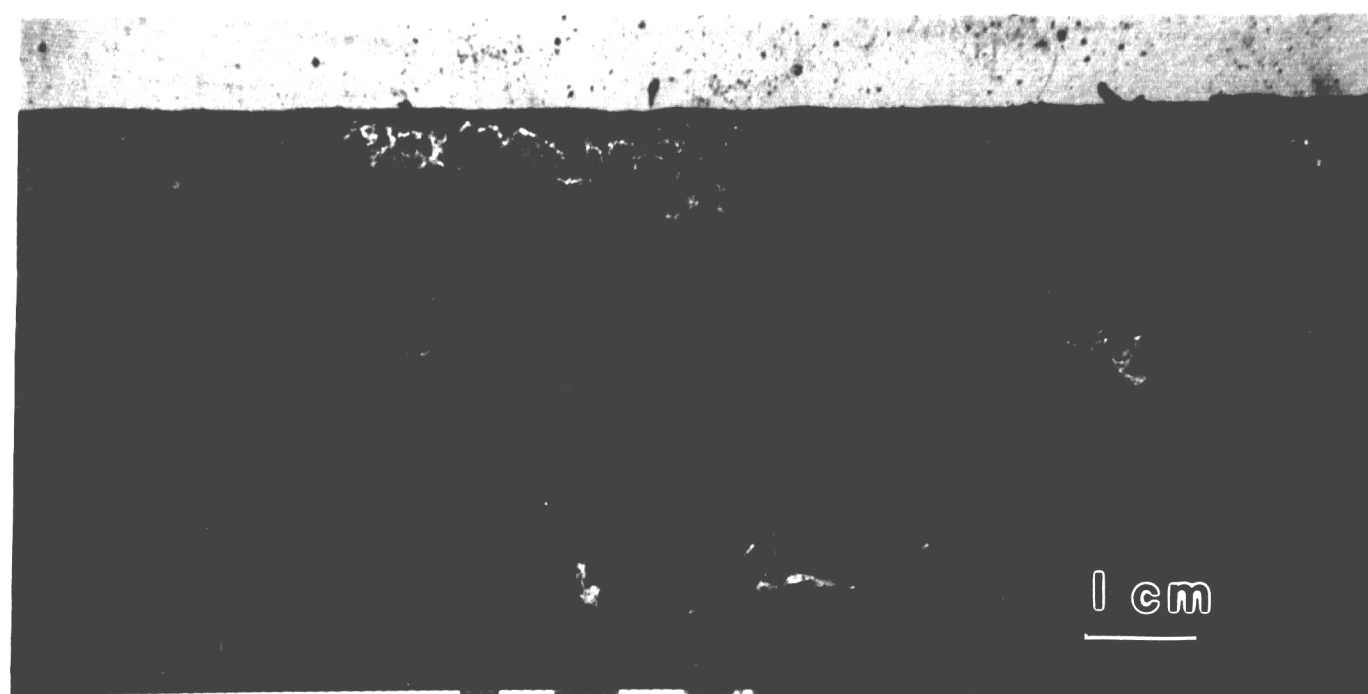
Figure 43. Surface Condition of a ASTM A572 Steel Plate Without Mill Scale and Exposed for 1800hr. In A Salt Water Environment. (Specimen FNSE2)

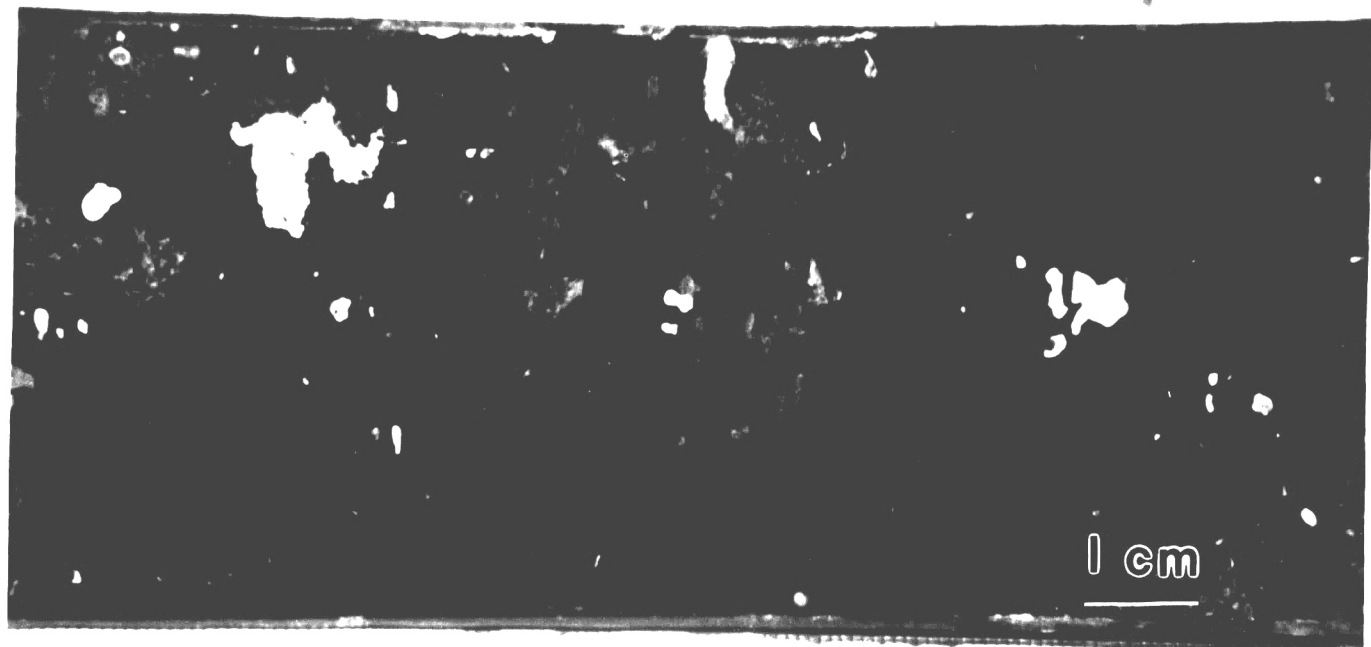
Figure 45. Surface Condition of A ASTM Steel Plate Without Mill Scale and Thermally Oxidized for 100hr at 560°C (Specimen FS1).

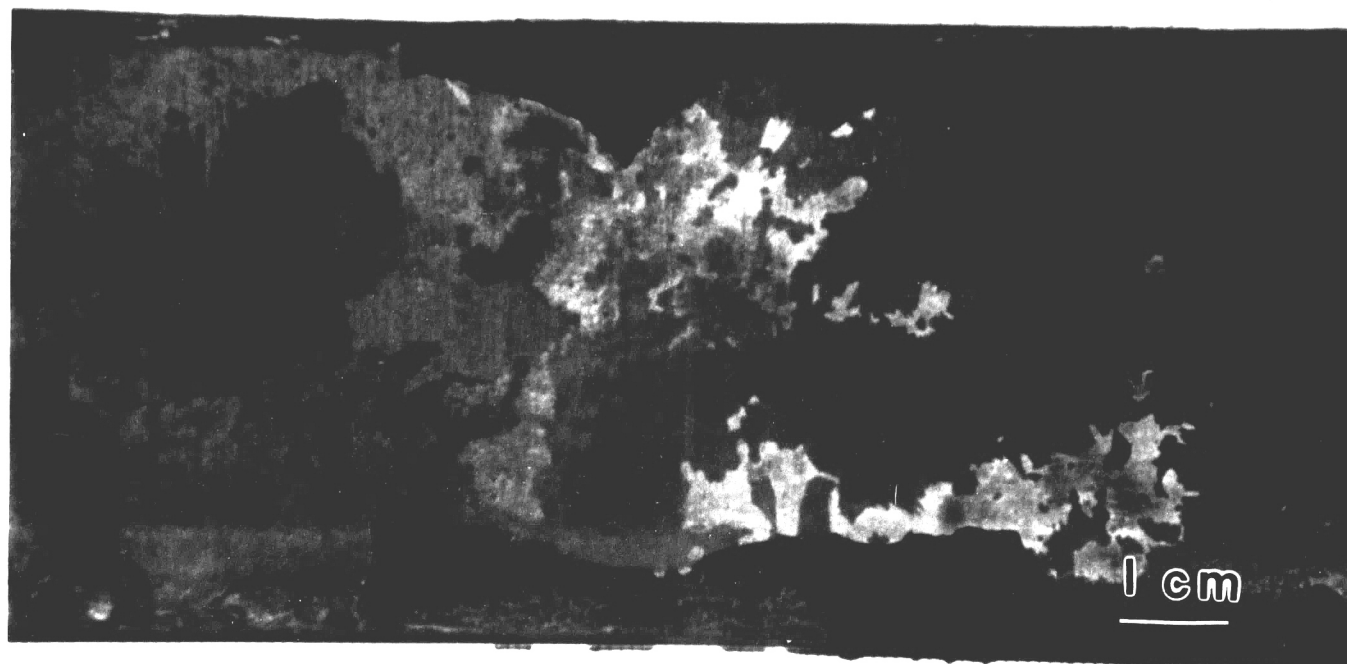
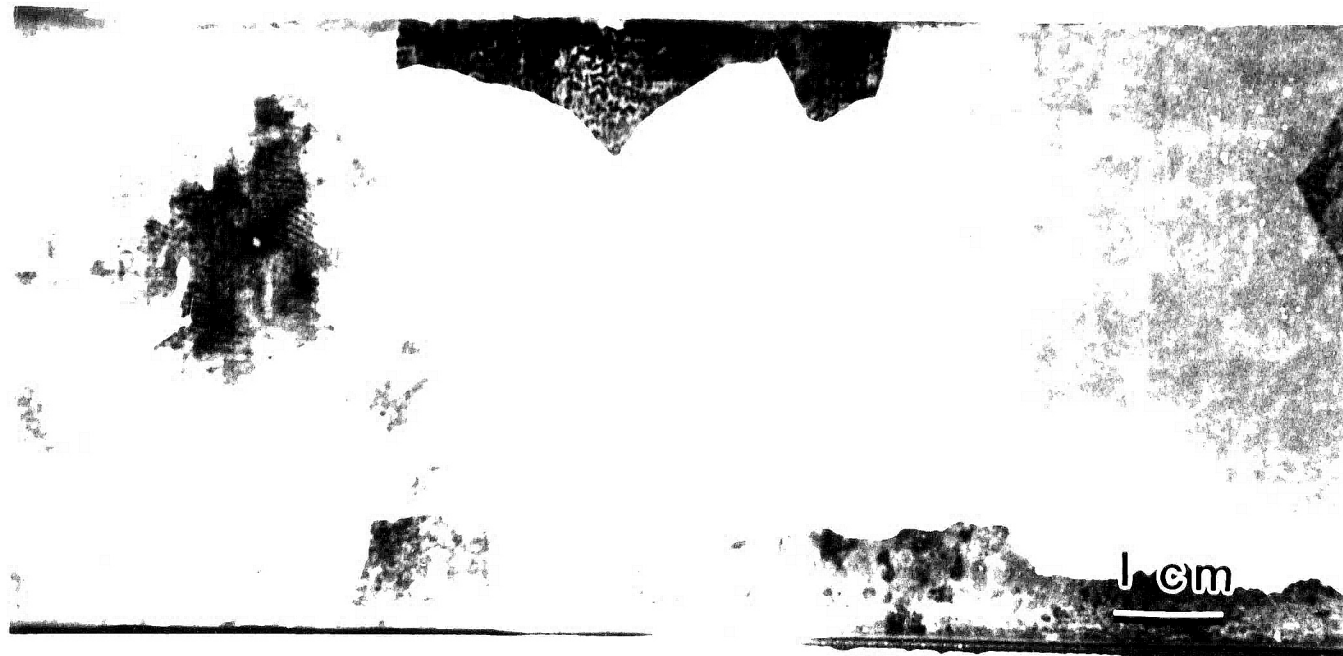
Figure 49. Surface Condition of a ASTM A572 Steel Plate Without Mill Scale And Thermally Oxidized for 10 hrs. at 960°C (Specimen FS3) Note the various oxide layers. They grey oxide layer was very hard and brittle and was not bonded very well to the specimen.

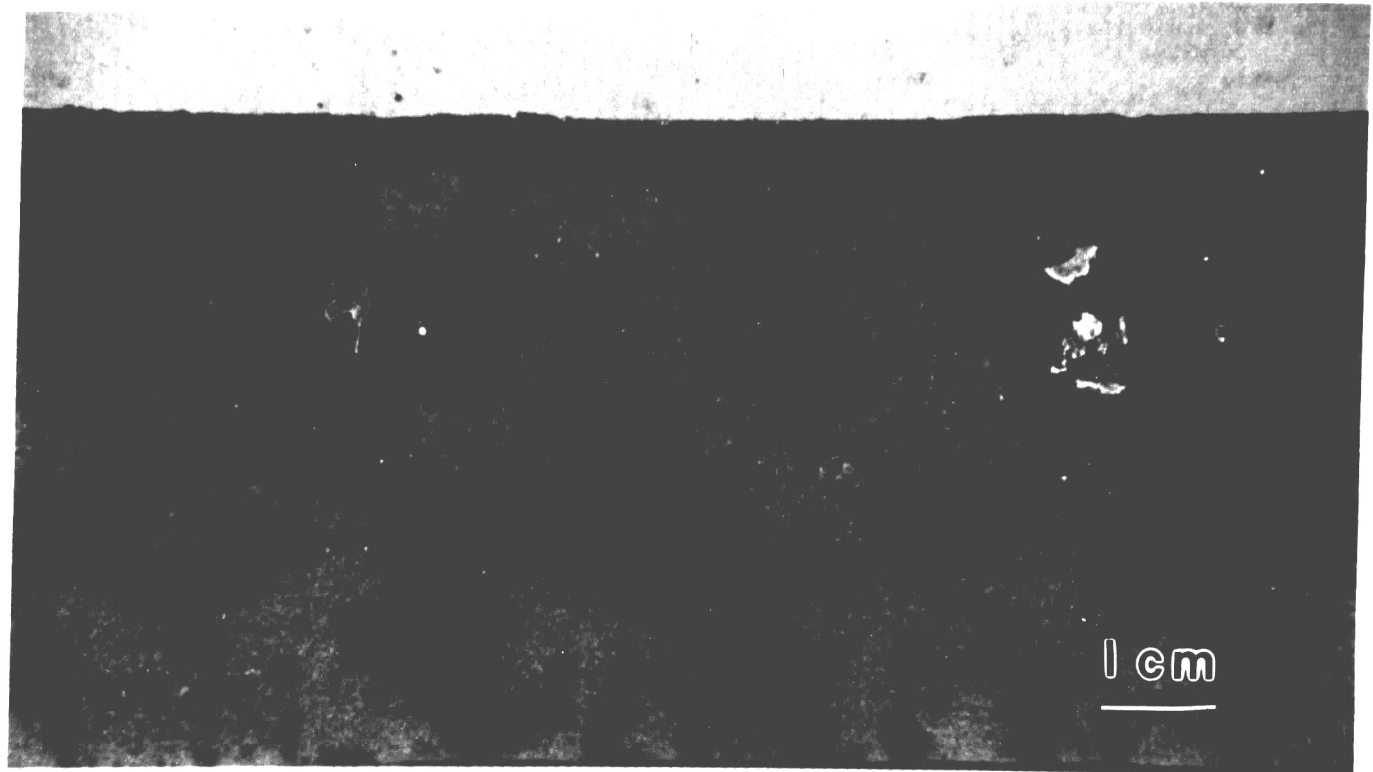
Figure 54. Surface Condition of Four Point Bend Specimen Fabricated From a Salvaged Column E1-LC After Oxides Were Removed and Exposed To a Salt Water Environment for 1200hrs. (Specimen IE2).
